Manhole Inspection Summary

Manhole # S37S__036MH

Inspection ☐ Is Incomplete Rating: **3) Fair**

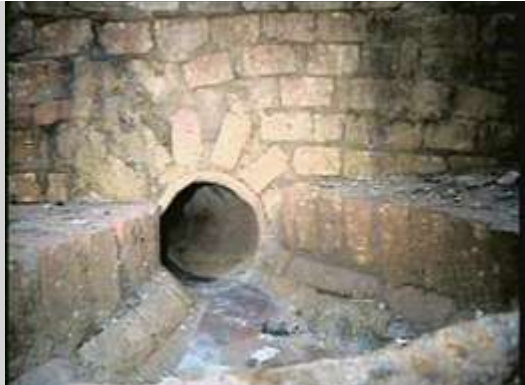
12 O'Clock Outflow

8 in. Circular Gravity Sewer
Pipe Out @ 12 O'Clock

Pipe Material: **Clay** ☐ Pipe Lined

Invert Depth: **10.50** (ft.) Flow Characteristics: **Fast**

Deposits: ☒ None ☐ **Mud** ☐ Sludge ☐ Debris ☐ Grease

Infiltration: **None** Pipe Seal Cond: **Unknown**

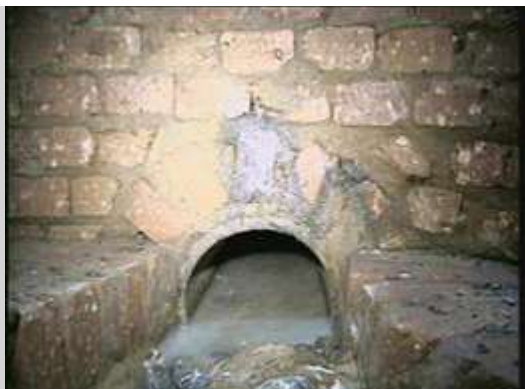
9 O'Clock Inflow

8 in. Circular Gravity Sewer

Pipe In @ 9 O'Clock

Pipe Material: **Clay** ☐ Pipe Lined

Infiltration: **None**
